Navajo Abandoned Uranium Mine

Site Screen Report

Black No. 2 Mine (West) AUM Site

March 2010

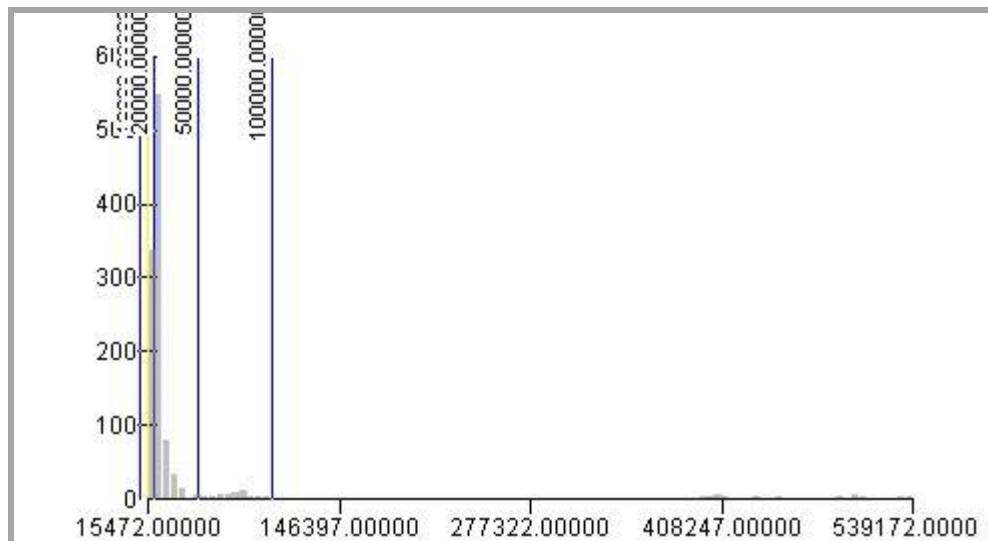
The following chart and statistics were generated by ESRI ArcGIS 9.3.1, and show the general distribution of the site gamma radiation measurements. The horizontal X axis represents the gamma radiation reading levels in cpm (lowest levels to the left). The vertical Y axis represents the frequency of each gamma radiation level.

Count:	1112
Minimum:	15472.00000
Maximum:	539172.00000
Sum:	49109461.00000
Mean:	44163.18435
Median:	22374.00000
Standard Deviation:	87554.58180

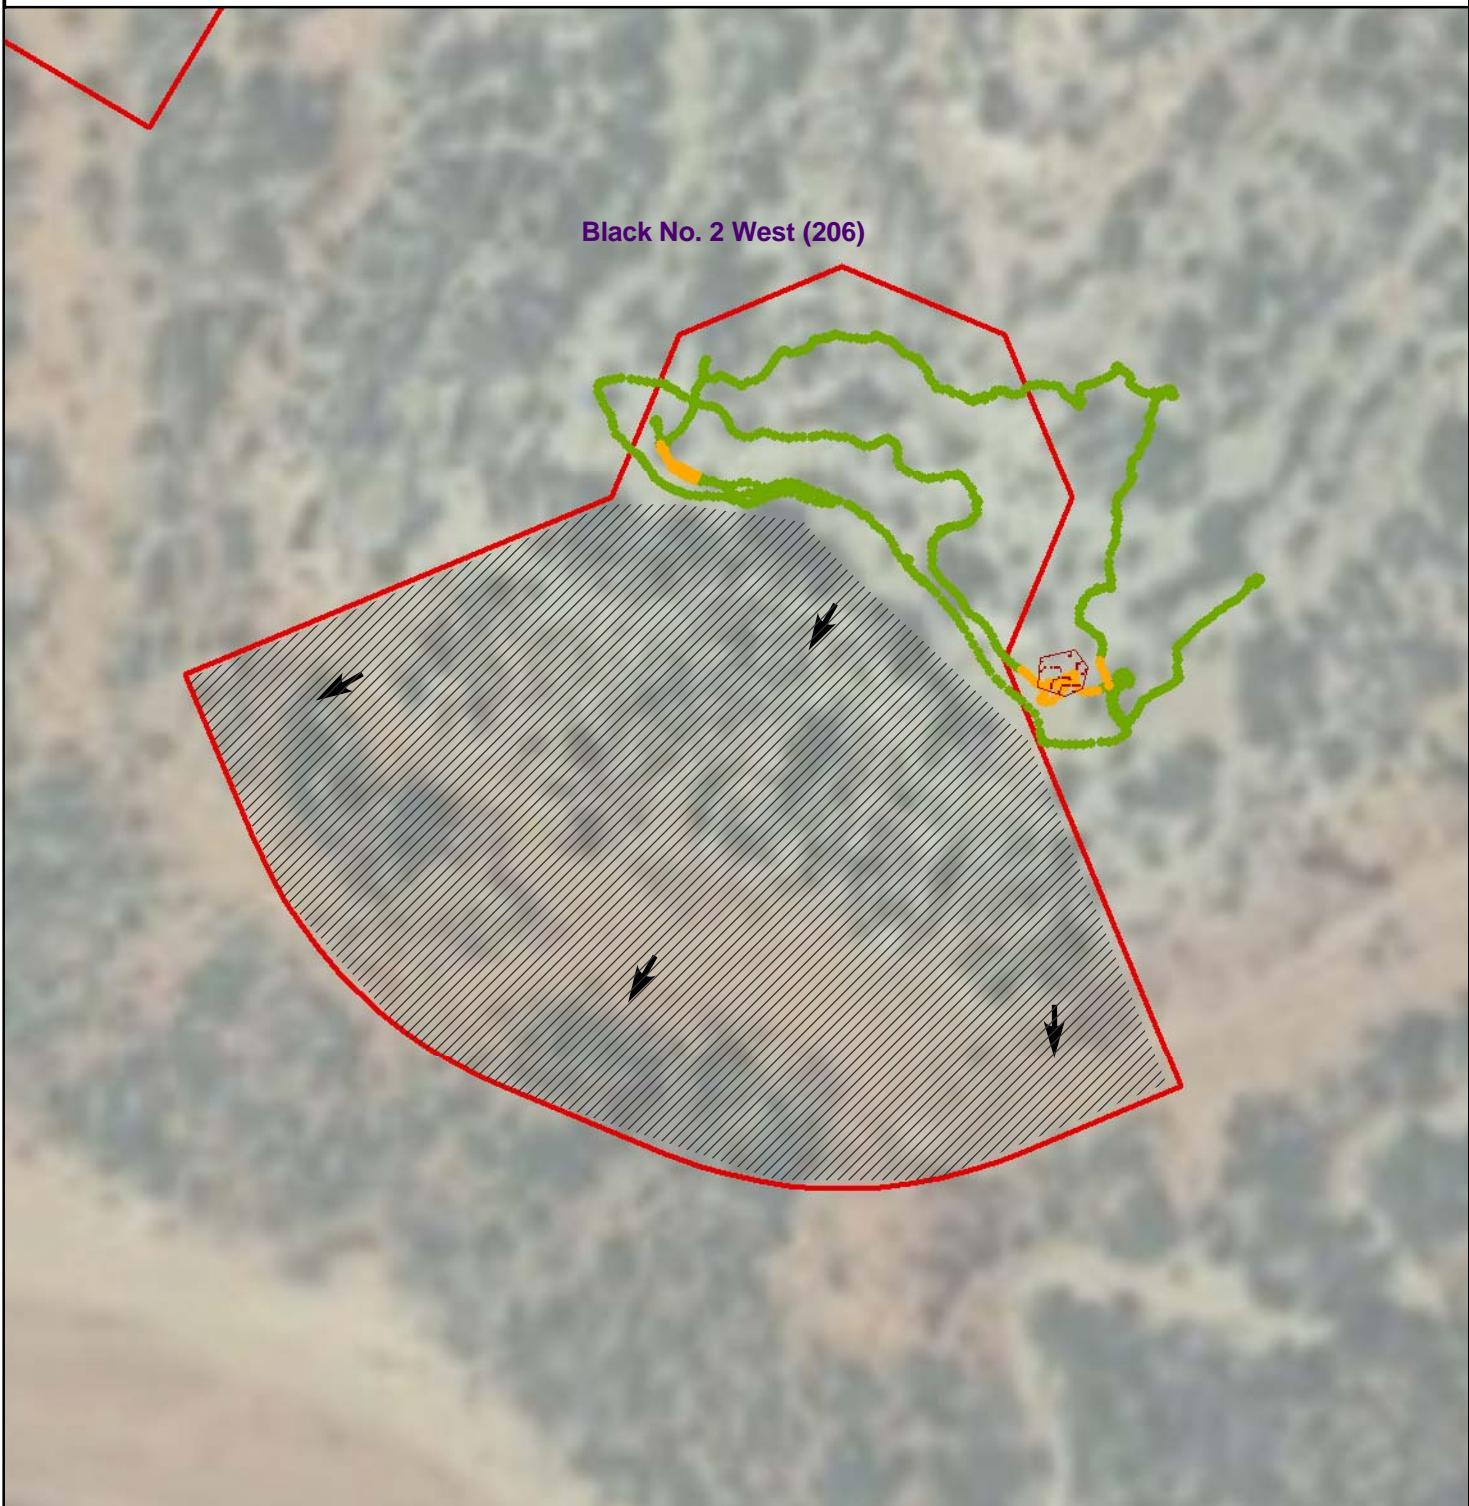
Figure 1 - Gamma Radiation Measurements, Above Two Times Background
Black No. 2 West (206)
Round Rock Chapter, Navajo Nation, Arizona

A total of 1,112 gamma radiation measurements were collected from the mine site, ranging from 15,472 to 532,172 cpm. Measurements in the vicinity of the waste debris were found at levels of approximately 530,000 cpm, and at an observed metal road of approximately 24,000 cpm. The measurements are represented in Figures 1 and 2.

Small waste pile at southeast, approximately 6' x 6', with a total estimated volume of 7 yd³
